INTERNATIONAL JOURNAL OF SUSTAINABLE Building Technology and Urban Development

Forensic assessment of a fail head wall of Hume Pipe Culvert: Focus on Geotechnical prospective

Dharmendra Kumar Srivastava¹, Amit Srivastava², Anil Kumar Misra^{3*} and Vaishali Sahu¹

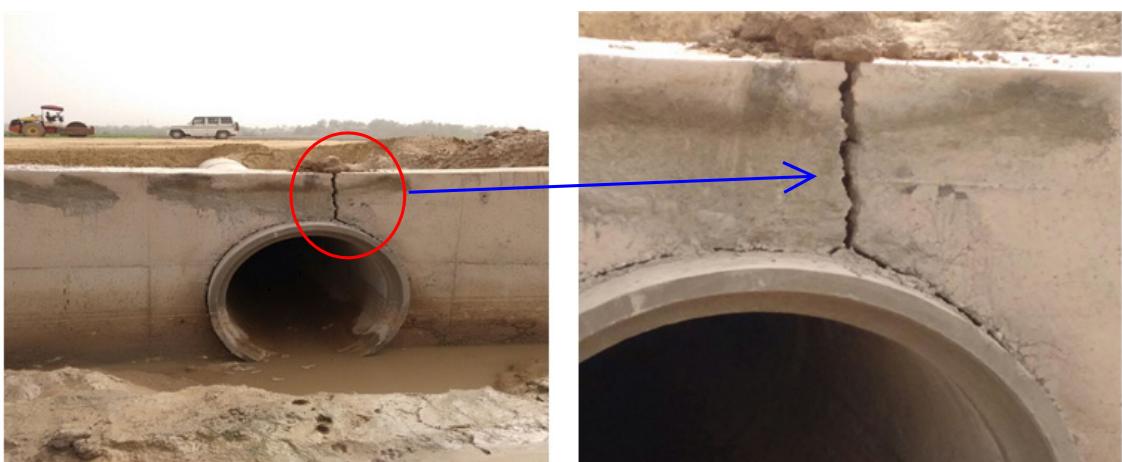
For cross drainage of accumulated water from upstream side (U/S) to downstream side (D/S) of one of the National Highways (NH), a 1200 mm diameter Hume Pipe Culvert (HPC) was proposed on a bypass. The construction of Hume pipe culvert was considered as the part work of Four Laning & strengthening of the national highway. For protection against the scouring or undermining of fill or a flow diverting device of HPC, headwall is generally constructed to confine the road laterally at two ends of culvert and also serve as a retaining wall. As per information and records, the construction of these culvert started in the month of June 2016 and was completed by the mid of July 2016. Soon after the construction, cracks were visible in the month of August 2016 during inspection. Similar observations were made at several other locations and severity of these cracks was increasing and with time and gradually the crack reached width of 5mm to 10mm within a span of one month (Figure 2). Figure 3 shows typical geometrical details of Hume pipe culvert. To determine the reason and remedial method for this problem was a serious concern to the technical team involved in the construction.

Figure 2. Crack development in the head wall of a typical Hume Pipe Culvert (HPC).

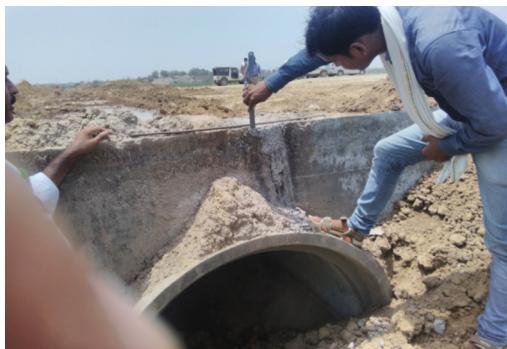
Figure 5(a). Measurement of settlement of head wall and **Figure 5 (b).** collection of soil samples for laboratory comparison with RLs.

It can be observed that RHS of head wall settled more as compared to the LHS of headwall, however, the settlement was uniform. On the LHS, the amount of differential settlement was 0.065 m(209.337-209.272) and 0.042m (209.314-209.272) on both side of the culvert. Similarly, on the RHS, the amount of differential settlement was observed to be 0.083 m(209.178-209.095) and 0.053m(209.148-209.095) on both side of the culvert. This might have caused stress concentration at the location in head wall and cracks were developed. Total amount of settlement from the original RL (209.37 m) of the head wall was estimated as 0.063 m, i.e., 63 mm (LHS) and 0.230 m, i.e., 230 mm on the RHS.

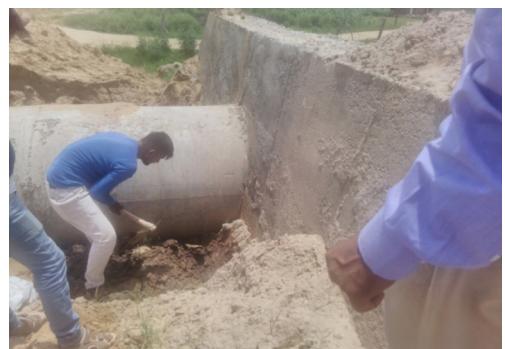
Soil samples were collected from the both side of Hume pipe culvert below head wall (Figure 5b) and its properties like grain size analysis, Atterberg's limit and free swell Index and compaction characteristics have been checked in site laboratory. Table 2 summarizes geotechnical properties of the field soil.

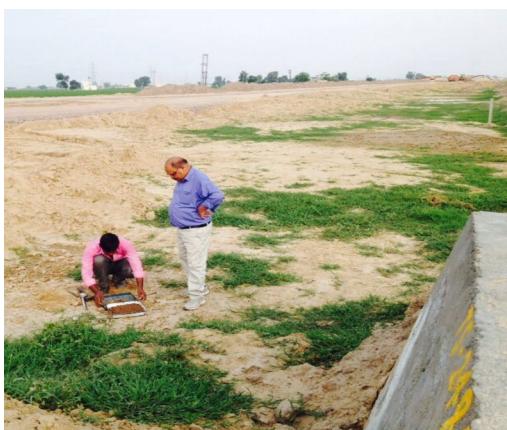
Figure 5(c). In situ density measurement using sand **Figure 5 (d).** Investigation for construction deficiency. replacement method.

It can be observed from here that the soil was very well compacted on the LHS of the culvert and the relative compaction (RC) value of more than 95% was achieved and hence settlement of the LHS of the culvert was less. However, soil on the RHS of the culvert was poorly compacted and RC of only 85% was achieved which might have caused excessive settlement of the head wall. The amount of settlement has been estimated from the following formula (Eq. 1).

As the subgrade soil was found to have compaction of 85% only, it is acting as a fill material and does not able to share the load. However, if the soil is well compacted and higher density can be achieved; it can be helpful in distributing the load properly.

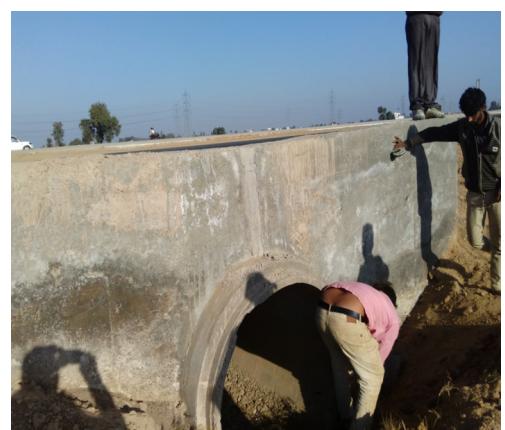
- a) Original ground level was not properly compacted before laying the PCC bed, which results in less bearing capacity of the soil.
- b) The PCC of the bed foundation was laid and appropriate curing time (Min 7 days) was not provided and next course of concrete work was started (laying and joining of pipes and head wall). Hence the PCC could not achieve the desired strength.

- By eye witness interview, it has been brought to notice that there was no proper compaction below foundation of headwall and the construction of head wall was done in a hasty manner. There was no enough time gap between casting of leveling course (P.C.C.-M15) and raft of headwall. It was also noticed (Figure 5d) that P.C.C. below Hume pipe connecting to raft of head wall was also not laid with proper compaction.

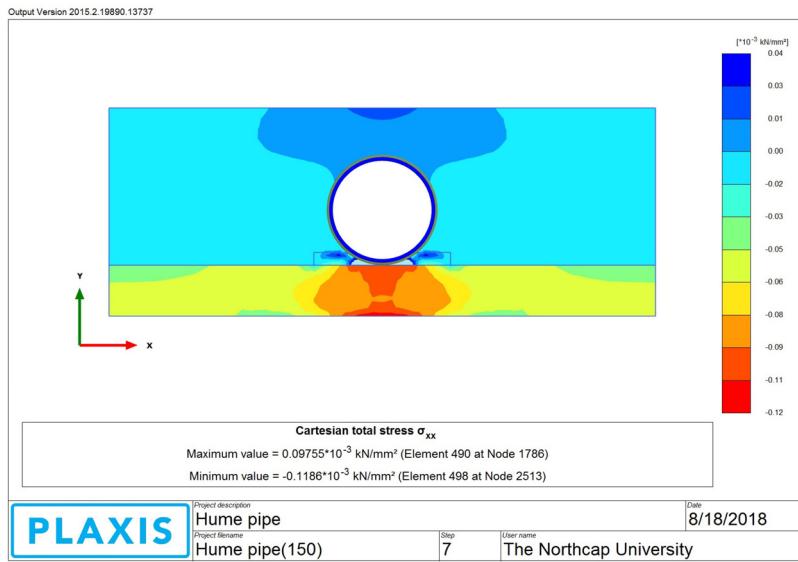
Figure 6 (a and b) shows the step followed in the numerical analysis of the Hume pipe culvert. From results of the analysis, it can be noted that both compressive and tensile stresses are developed in the head wall. Blue shade shows tensile stresses developed and red shades indicates development of compressive stresses in the Head wall. It can be noted that the tensile stresses developed in the head wall is at the location of the crown of Hume pipe where the crack was developed. As we know that concrete cannot take tension, development of tensile stress (97 kN/m²) has caused severe cracks in the head wall.

Figure 6(b). Stress concentration in Head Wall (blue shade for tensile stresses).

The FEM analysis of the existing head wall shows the development of tension zone at the top of the Hume pipe, which is responsible of cracks in the pipe (Figure 6b). Hence, it is suggested to provide nominal reinforcement (8 diameter @150 c/c) at the crown of headwall to increase its resistance against tensile forces. Figure 7.1 shows that when steel reinforcement is being provided the stress concentration has been reduced significantly.

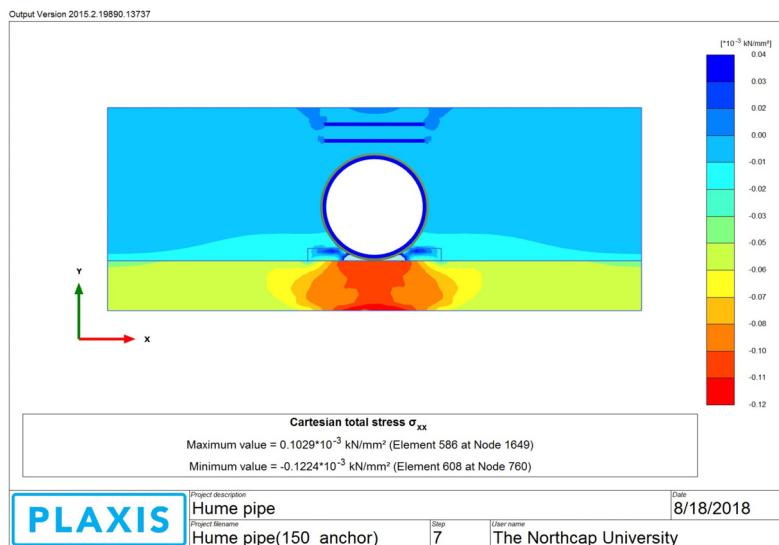
Figure 7.1. Stress development for reinforced Hume pipe.

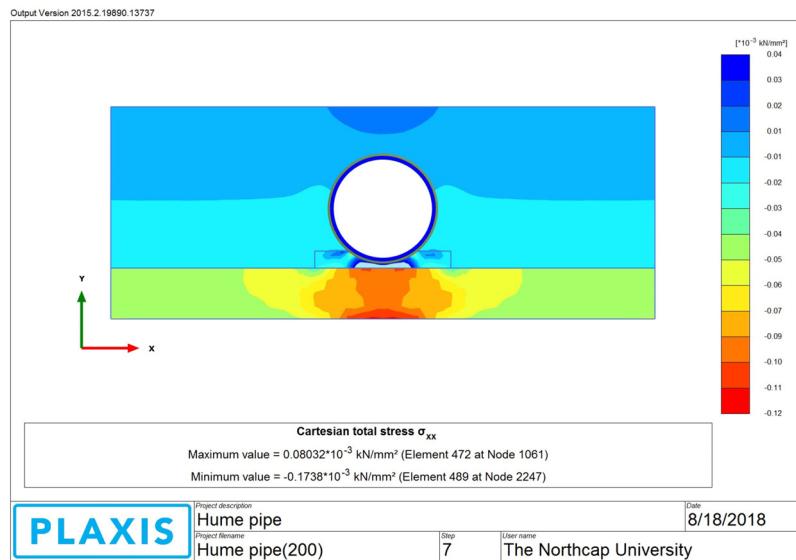
Figure 7.2. Stress development in 200 mm thick PCC base.

Presently 100 mm PCC was constructed as the base platform for the Hume pipe and headwall. If the thickness is increased it can effectively support the structure and thus can resist the failure. Figure 7.2 and 7.3 shows the stress development for a 200 mm and 250 mm thick PCC respectively. It can be observed from here the maximum value of stress has been reduced to 80 kN/m^2 and 69 kN/m^2 respectively for 200 mm and 250 mm thick PCC base.

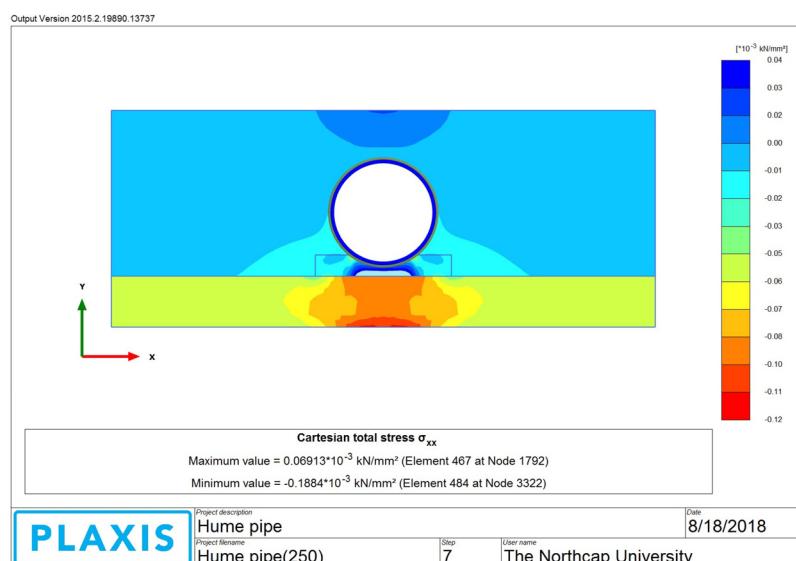
Figure 7.3. Stress development in 250 mm thick PCC base.
